OLD LOUISIANA STATE CAPITOL:  
Center for Political and Governmental History  
Baton Rouge, LA

Project Profile:

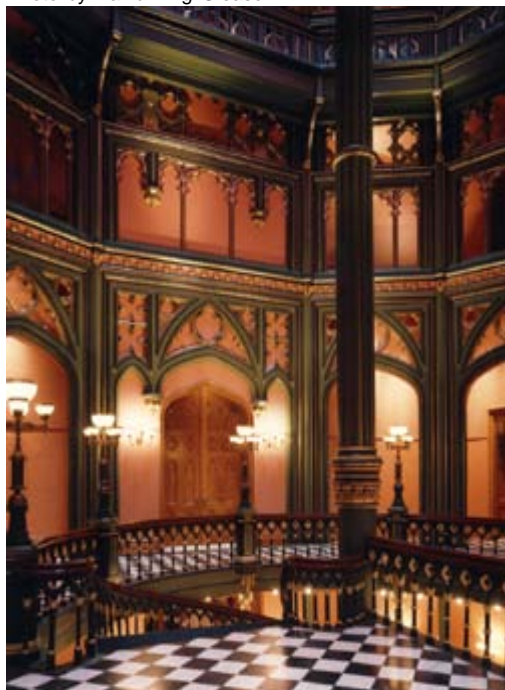
Restored Rotunda  
Photo by Richard Sexton

The Capitol was designed by architect James Dakin and completed in 1852. In 1862, during the Civil War, the building was gutted by fire. In 1880-82, architect William Freret, reconstructed the building adding a fourth floor and raised lantern to the central portion of the building. The dominant and unique architectural feature of the building is the Rotunda with its colored glass dome and use of cast iron both decoratively and structurally.

Planning and restoration processes included state-of-the-art methodology of research, documentation and programming. Restoration philosophy established the concept to focus exterior restoration on the original 1852 design, and interior restoration on the 1882 reconstruction. The colored glass in the fan vault dome was completely removed, supporting structure reinforced, and the original design recreated. Recreated color design and oak graining in the Rotunda and other major spaces is authentic to 1882. The assortment of existing flooring materials

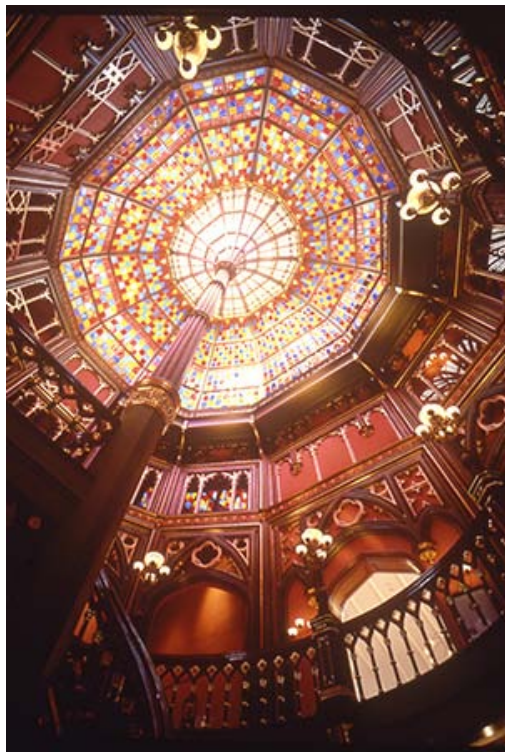
Restored Rotunda  
Photo by Timothy Hursley

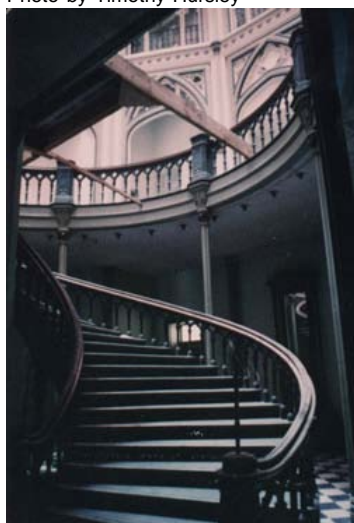
Rotunda Before Restoration  
Photo by Eean McNaughton

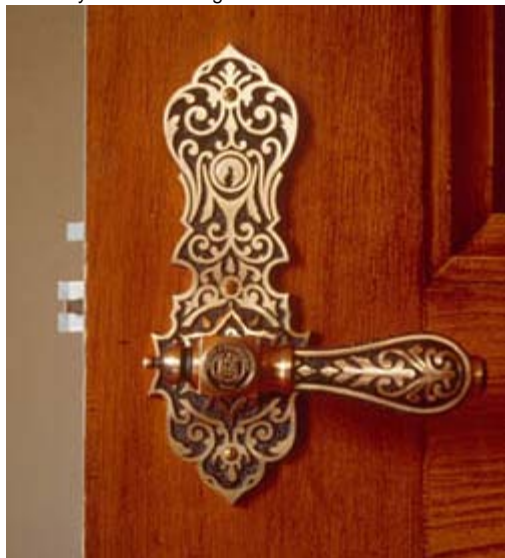
Replicated Door Hardware

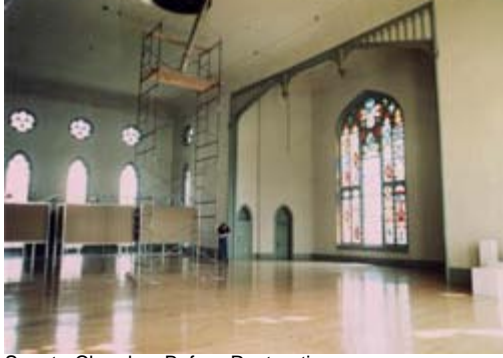
Senate Chamber Before Restoration  
Photo by Eean McNaughton

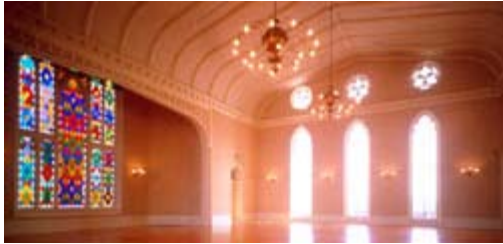
Restored Senate Chamber  
Photo by Richard Sexton
